Reconnaissance of damaged structures after the 2016 Muisne-Ecuador Earthquake

Dept. of Civil, Structural and Environmental Engineering University at Buffalo, State University of New York: Jerome S. O'Connor, PE, F.ASCE, Executive Director Bridge Institute and Enrique Morales Moncayo, Ph.D candidate.

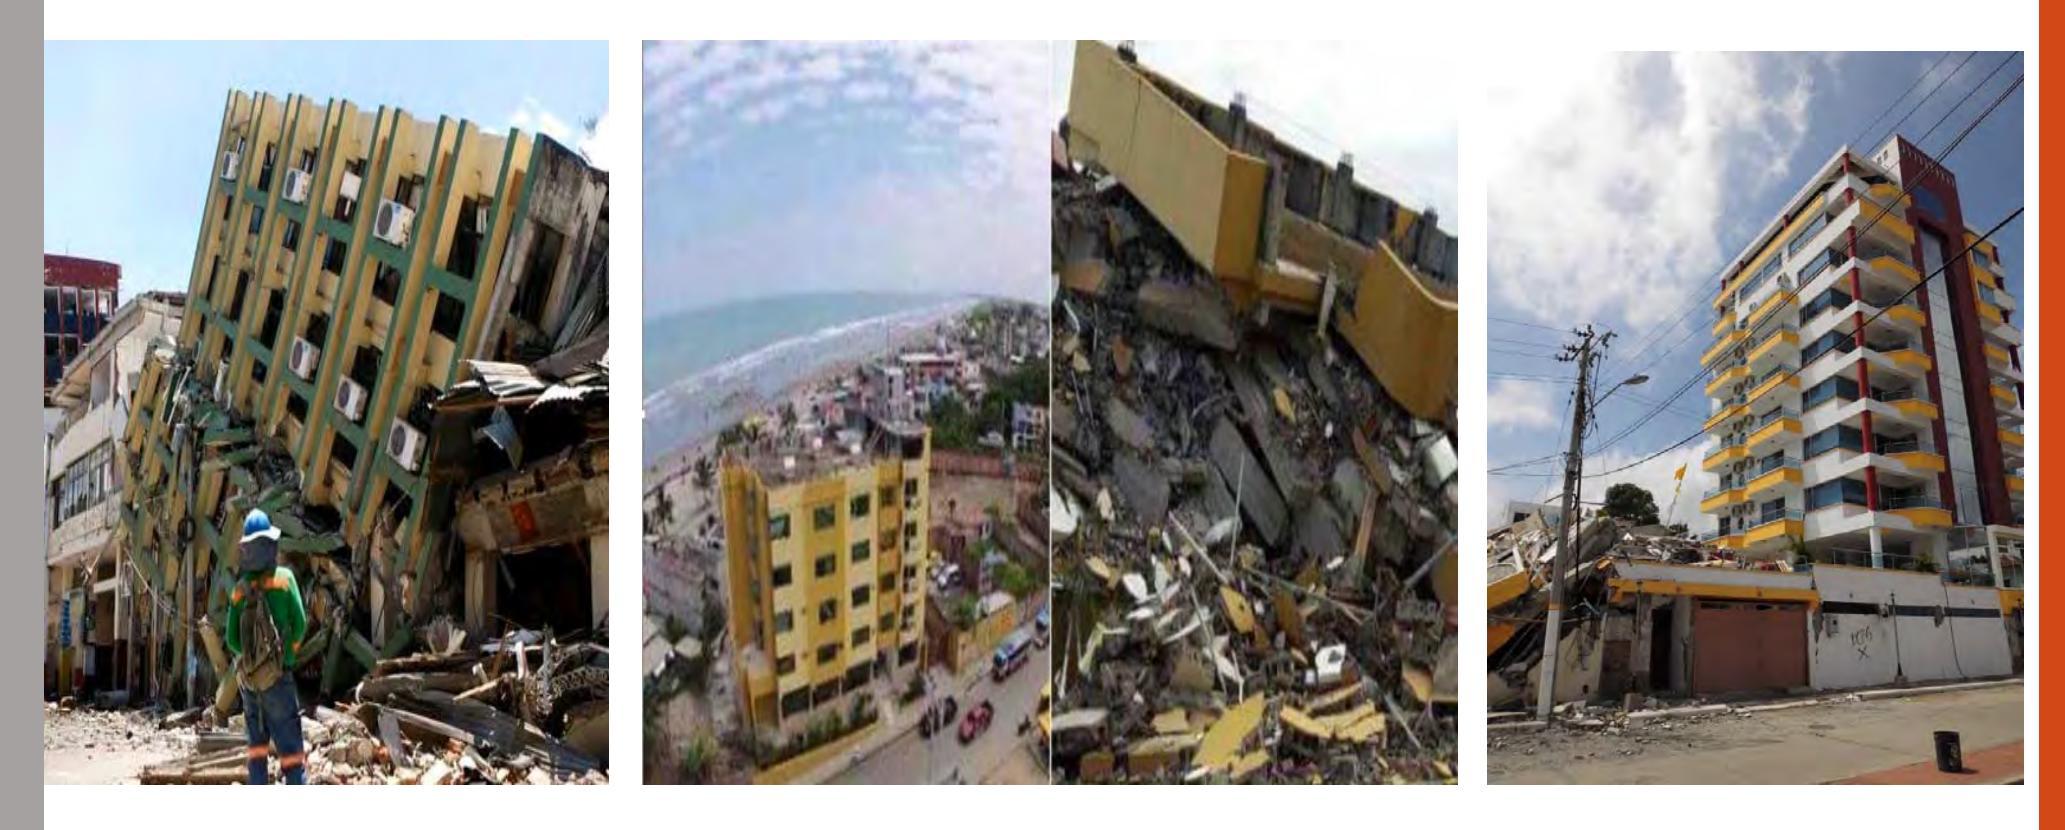
There were several buildings that completely collapsed

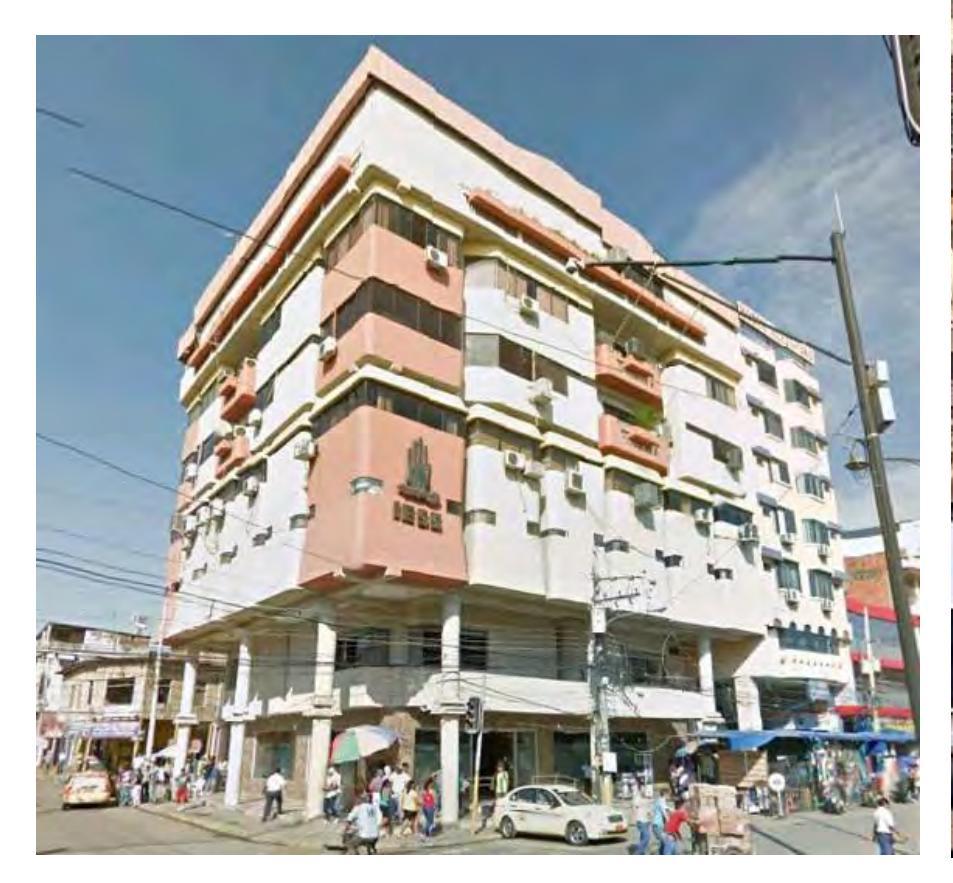
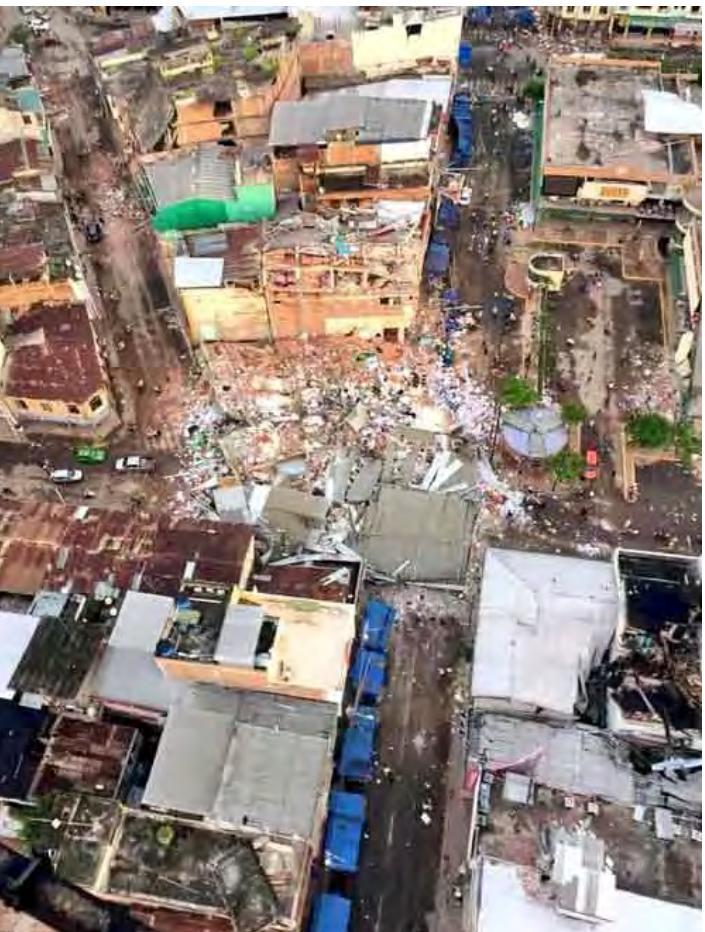
Portoviejo(170km, PGA=0.37g)

Ecuatorian Institute Social Security

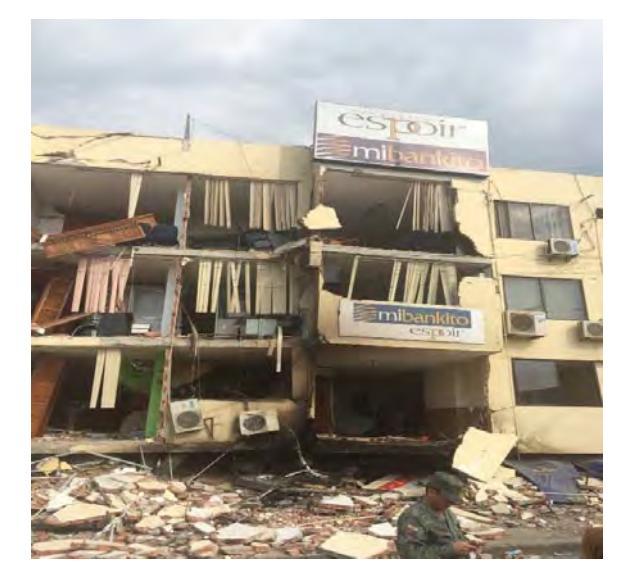
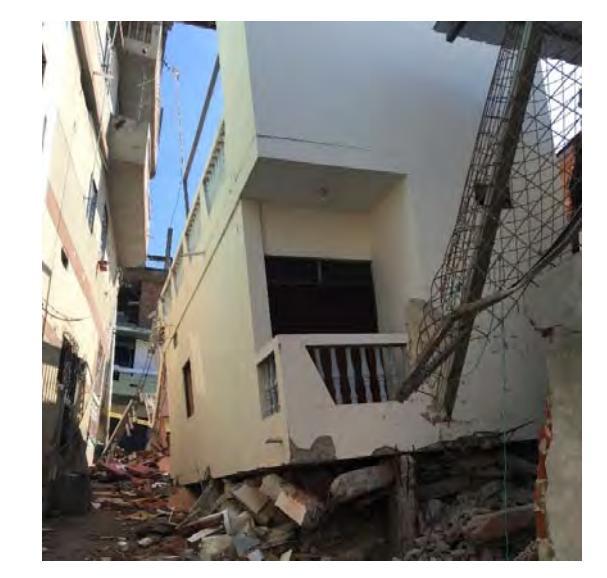
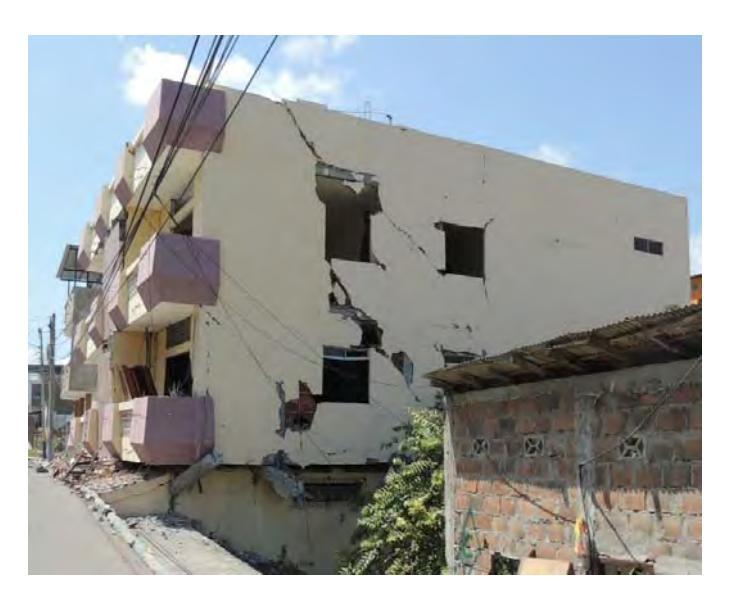
Soft Story failure. The first floor of these buildings collapsed

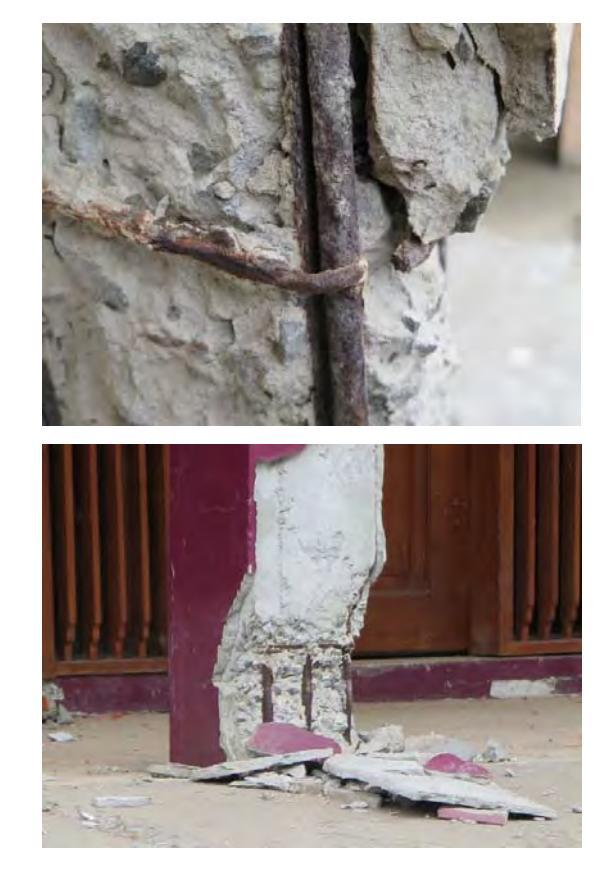
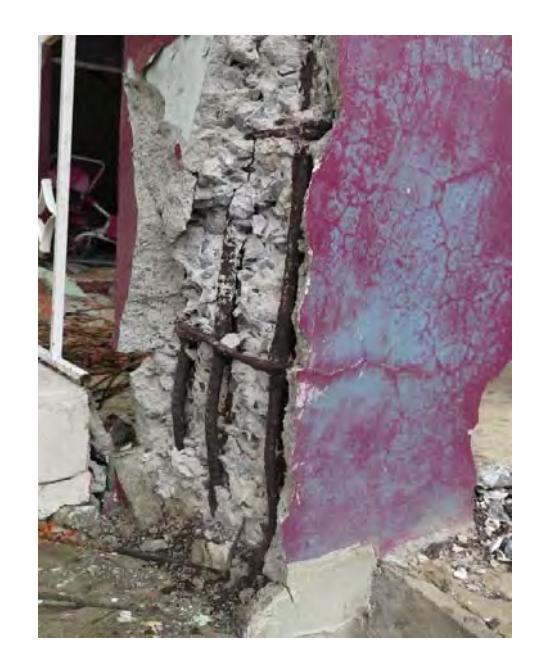
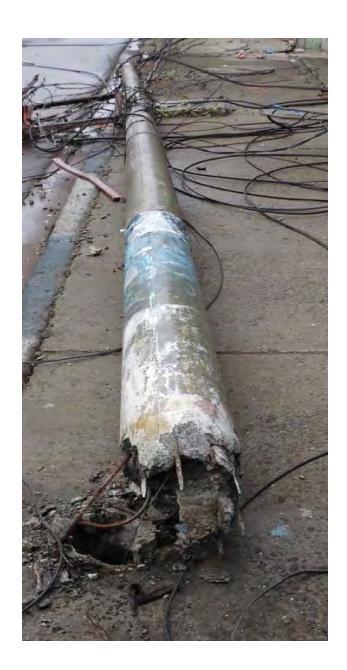
Sings of several corrosion on reinforced steel, collapsed electrical pole with corrosion and reduction of effective area of longitudinal steel.

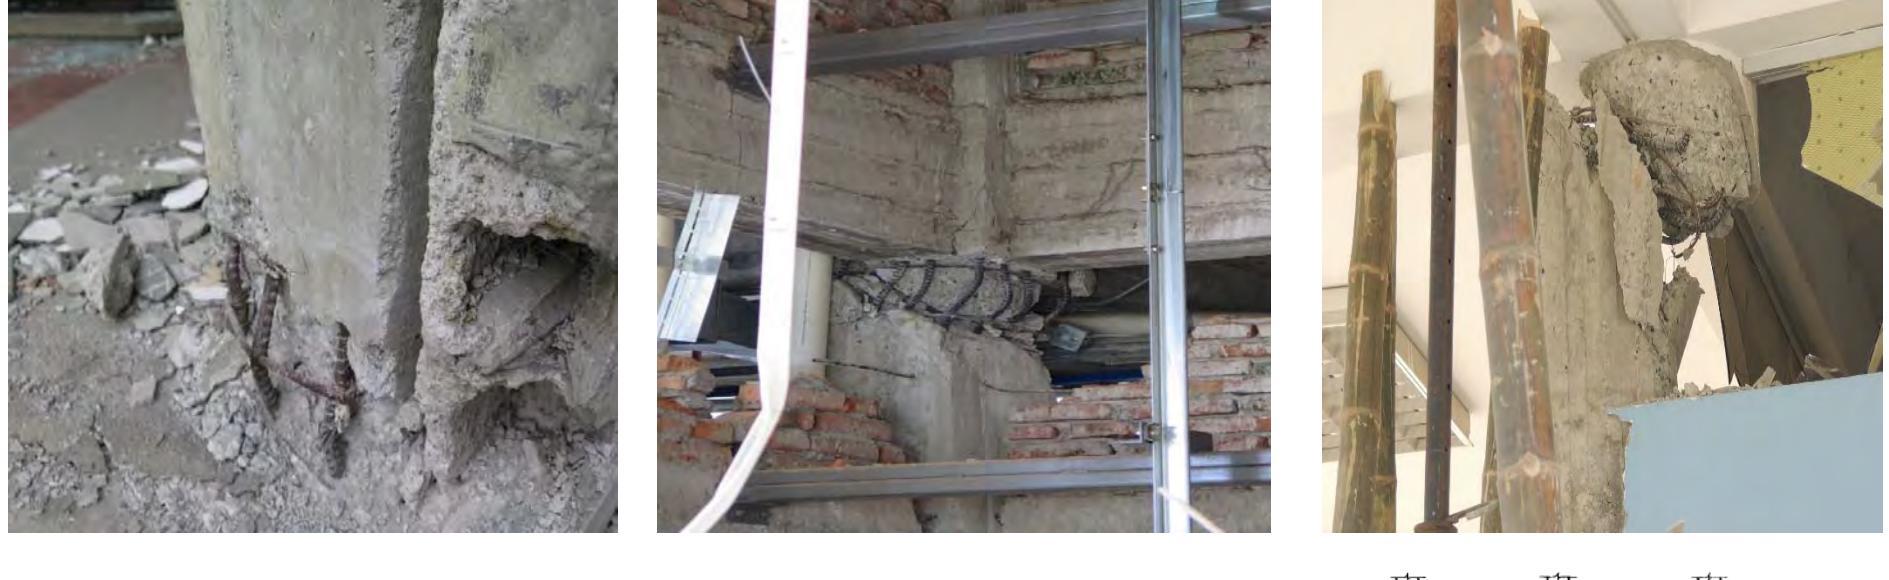
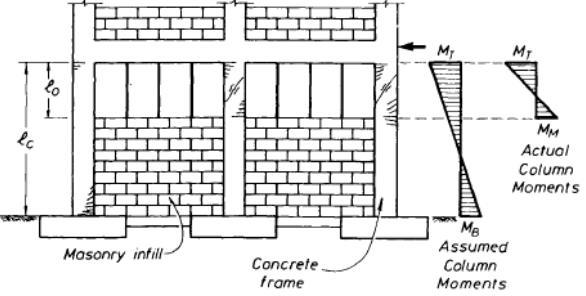
Plastic hinges formed in the columns of the buildings and residential houses. The masonry walls between columns restrained the column height and increases the shear demand when the plastic flexural demand concentrated at their ends.

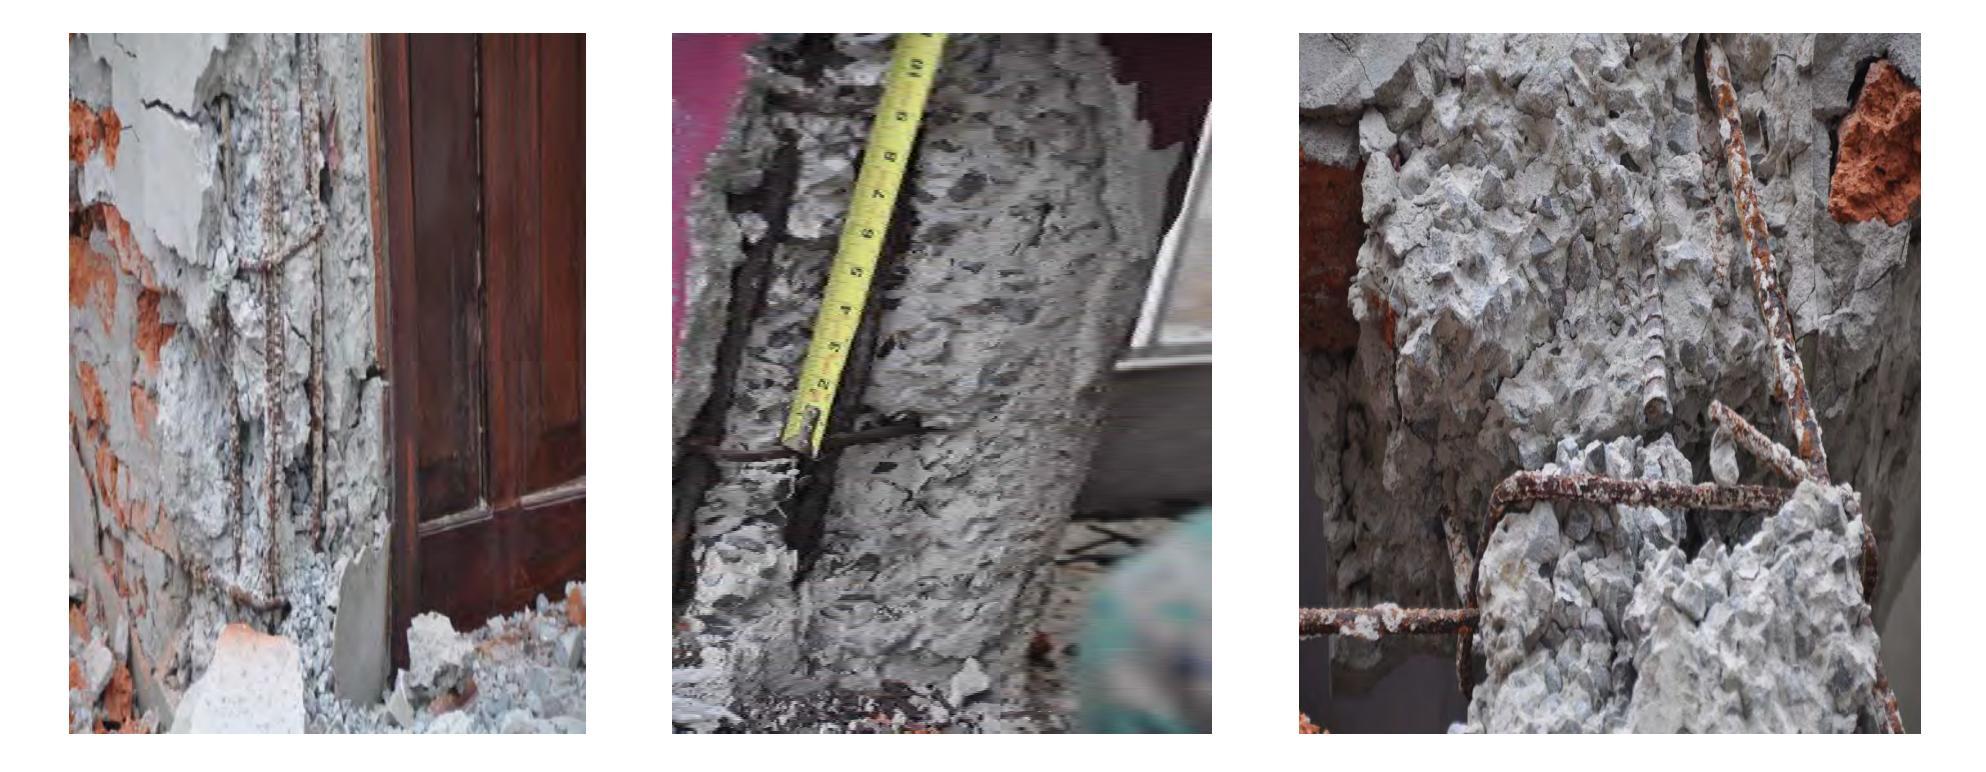
Stirrup spacing and discontinuity in the longitudinal rebars were observed in columns of some older multistory moment frame buildings.

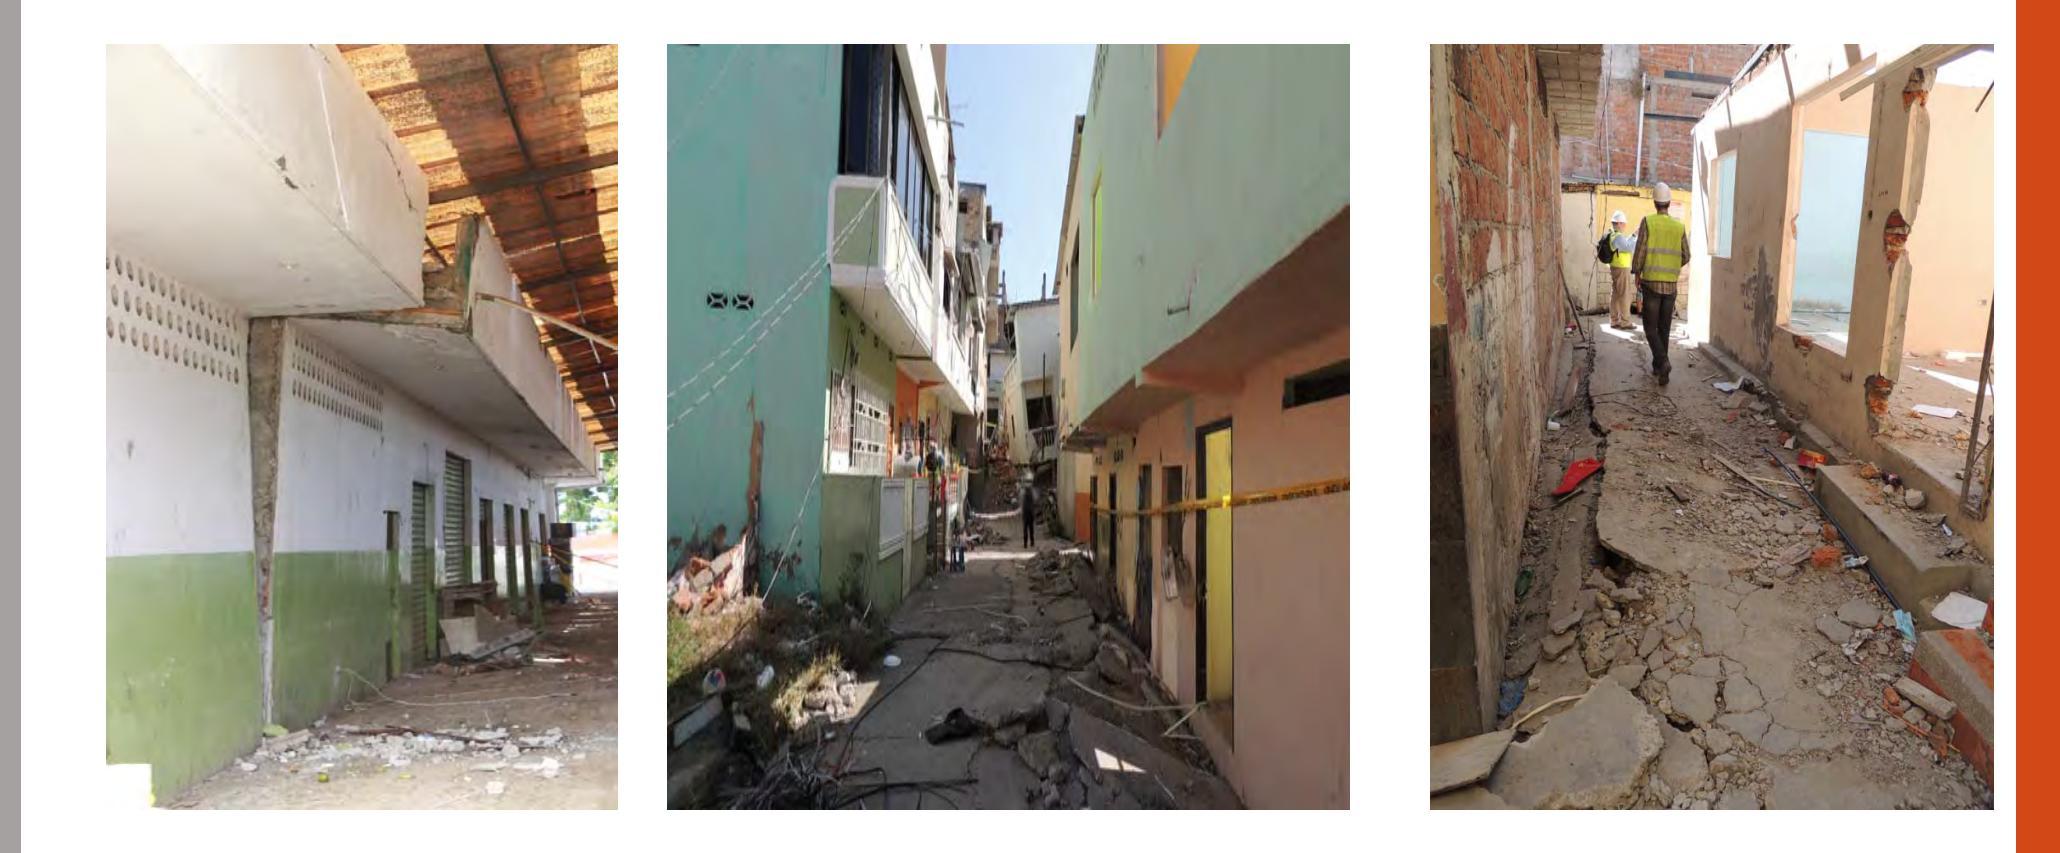
The settlement caused some building to sink.

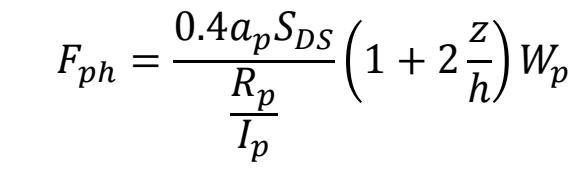
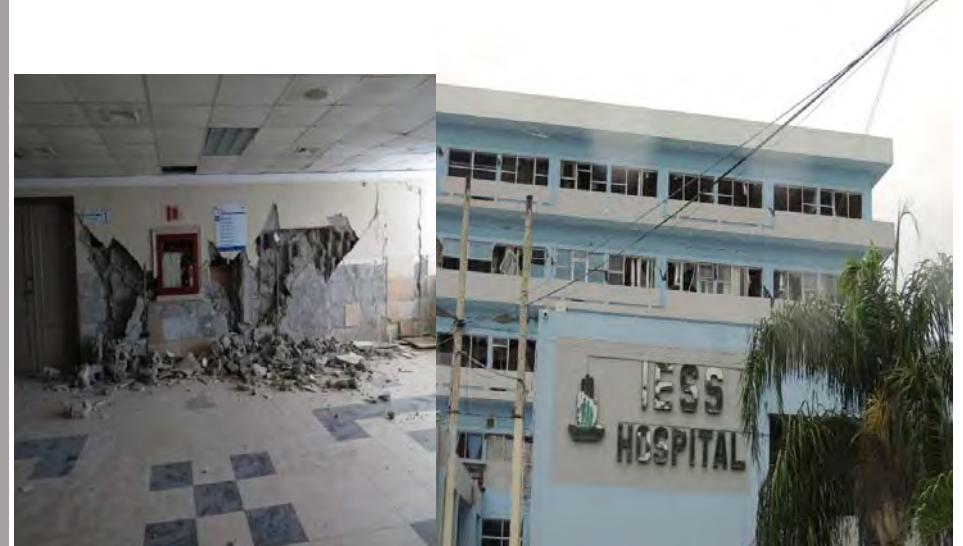
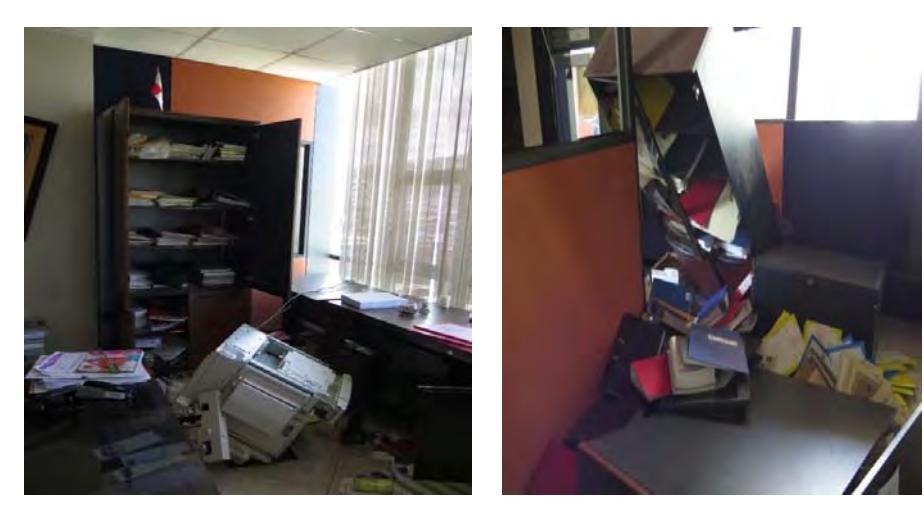
This Building/hospital suffered no structural damage, the building/hospital was completely closed because there was an extensive nonstructural damage related to nonstructural elements that are sensitive to drifts and acceleration.

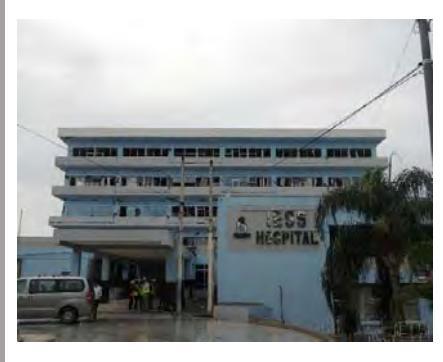
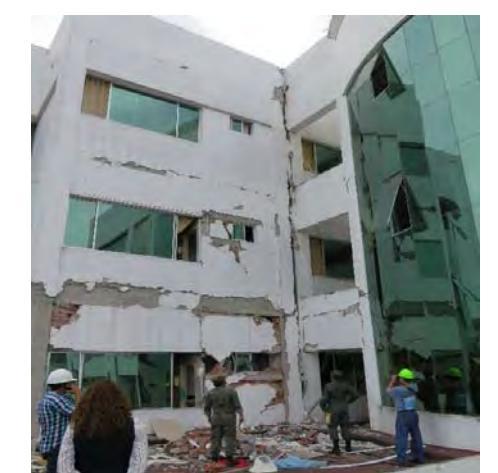
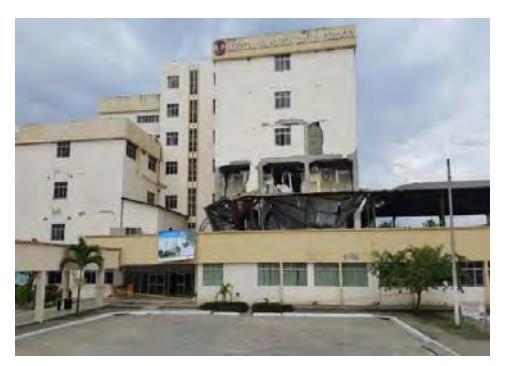
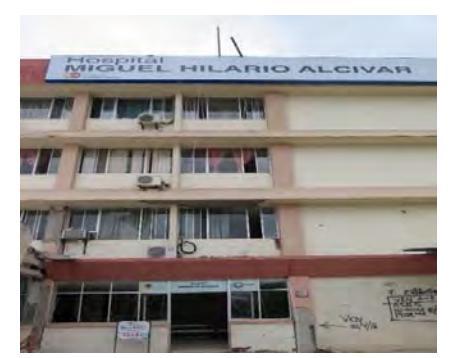
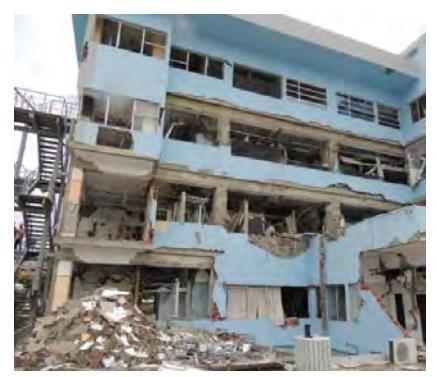
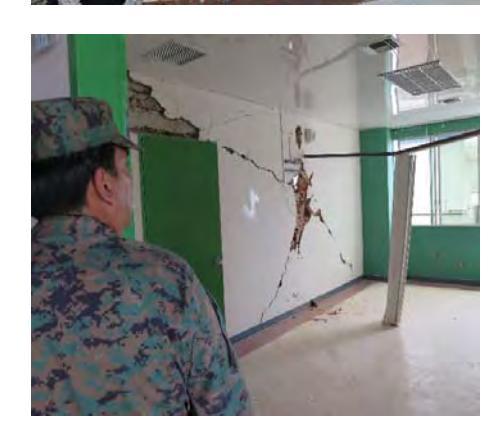
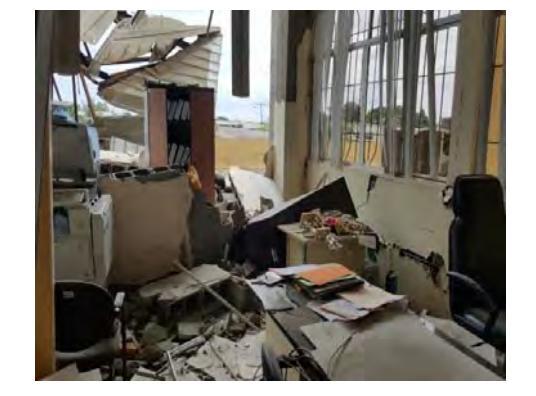
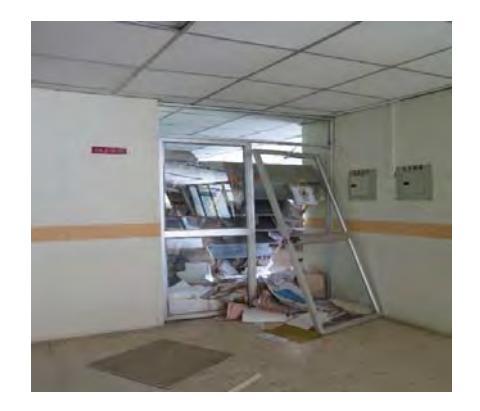
Although none of the hospital facilities collapsed, 22 were left inoperative in the province of Manabí and Esmeraldas due to severe damage to non-structural components. Medical assistance was provided from temporary shelters, resulting in overcrowding, lack of sanitation and increasing risk of epidemic disease transmission.

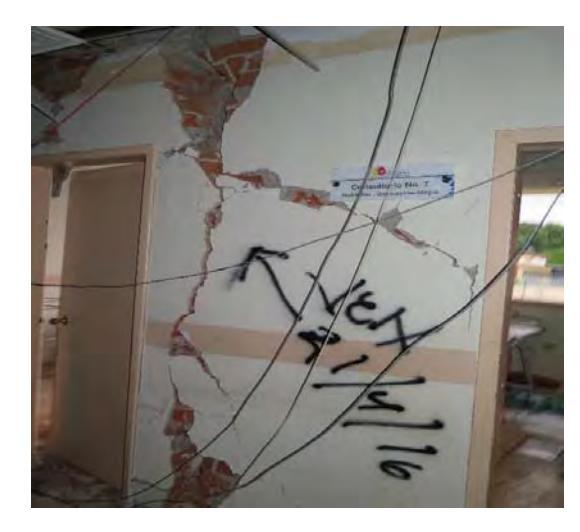
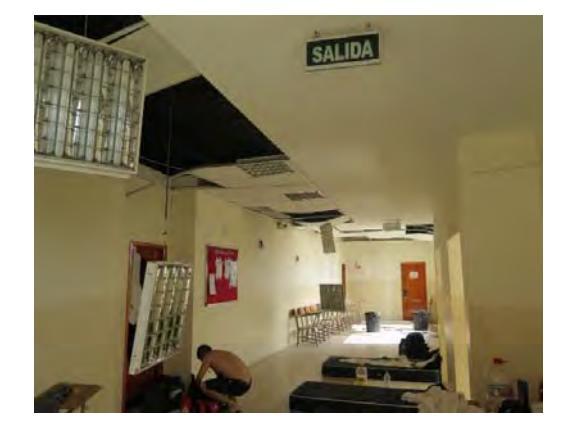
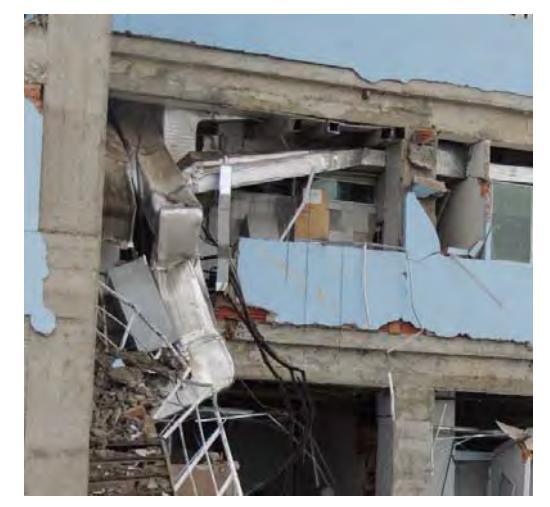
Masonry infill- Outpatient

Ducts and ceilings

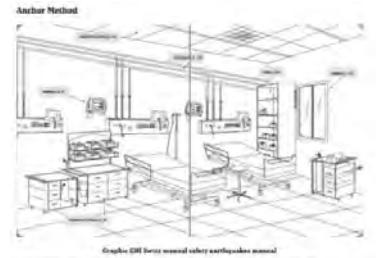
Dialysis Unit

Strong movements may lead to dialysis equipment slipping and the connections thereof breaking. Critical patients may be injured or even die due to the lack of power supply or lack of blood. Falling television equipment may cause patient death.

Mobile item such as dialysis machines and equipment, tables, thates, among others should be fastened to the walls with the appropriate supports to prevent movement.

Equipment situated on top of tables, this is secured in the same way as computers.
